Manhole Inspection Summary

Manhole # S19M__011MH

Inspection ☐ Is Incomplete Rating: **2) Good**

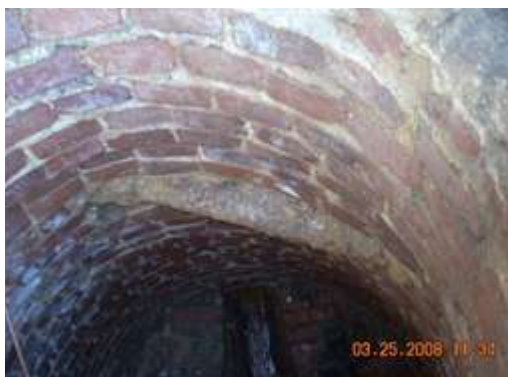
pipe coming through the corbel wall

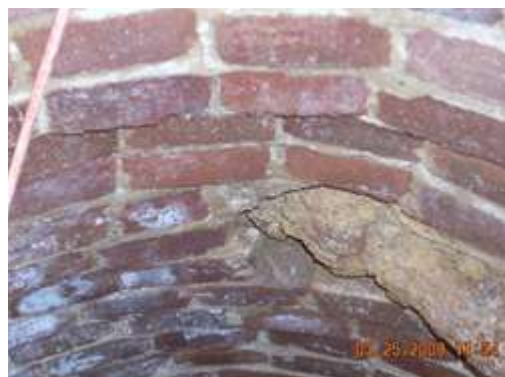
Defect 4

Condition: ☐ Sound ☐ Cracked ☐ Root Intrusion ☐ Loose Brick ☒ **Deteriorated**

deteriorated corbel

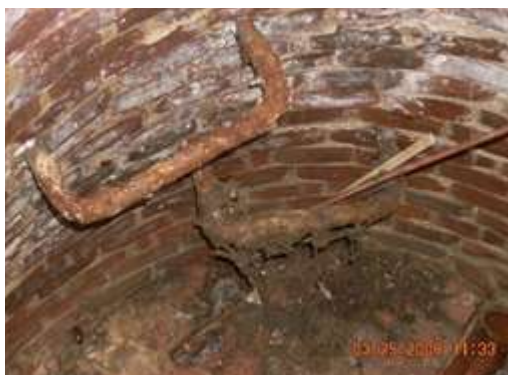
Defect 3

☒ **Evidence Of Surcharge** Depth: **2** (ft.) ☐ Active Surcharge Present

surcharge evidence on the step

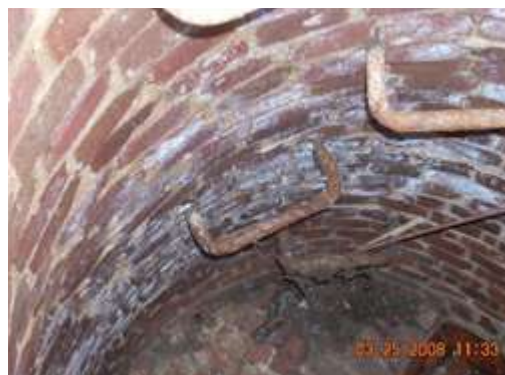
Defect 2

Count: **4** Missing: **0** ☒ **Corroded**

corroded steps

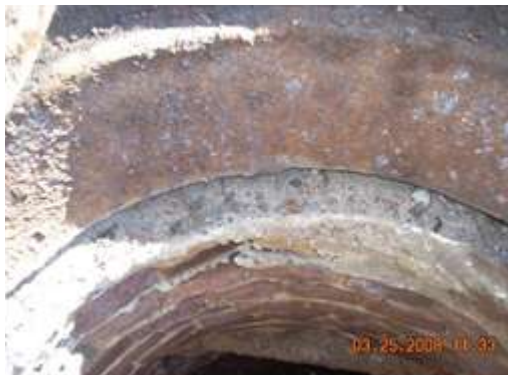
Defect 1

Offset: **1.5** (in.)

frame offset

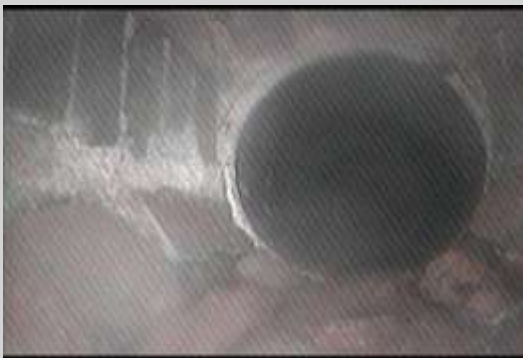
8 O'Clock Inflow

Infiltration: **None** Pipe Seal Cond: **Broken**
